**Flood Control Project Maintenance
Levee Inspections**

Maintenance Issue Types Only, Levee Inspection Report By Mile - Fall 2019

Sacramento Maintenance Yard Willow Slough Bypass

Waterway	Bank	Unit Miles	Inspection Start/End	Inspector
Unit No. 01 Willow Slough Bypass or North Levee	Left	5.05	10/16/2019 10/16/2019	Zach Jojola

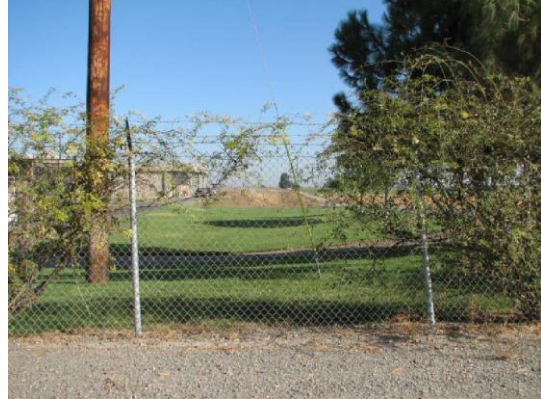
Photo 1 of 3 : UCIP_FA_2019_44903_22882.jpg

Comment Code					
Inspector Comment					
DS_ID:17834 FS_ID:44903 EP_NO: 10130 Repair Type: No Action Needed Crossing Status: Found UCIP Comments: 01/08/2019 Received updated permit information for this crossing from D. Biswas with the CVFPB. The structure description has been updated with the correct abandonment permit information. (O. Magana - DWR UCIP) 05/02/2017 CVFPB Letter sent April 12, 2012 regarding Permit #10130 - Internal Inspections of Pipes Crossing State Plan of Flood Control Levee. Permit No. 10130 previously referenced in UCIP record was removed--permit does not reference 36-inch pipe. (O. Magana - DWR UCIP) 04/12/2017 Mud/debris on WS removed by JK, RF. (C. Lund - DWR Sacramento Yard) 05/05/2015 Removed debris from the outlet. (C. Lund - DWR Sacramento Yard) 09/19/2012 Minor debris blocking flap gate. Debris/log needs to be removed from the outlet. (P. Amatya - DWR UCIP) FIELD_STRUCT_DESC: 36-inch corrugated metal drainage pipe through the levee, 18 feet below the crown. Flap gate is located on the waterside (WS) end. (no permit was found authorizing 36-inch pipe [pipe is referenced in O&M Manual, Station 271+54]; 36-inch was authorized for abandonment under Permit No. 12789-1, 2018 - City of Davis) [Additional Reference(s): USACE Sacramento O&M Manual Unit 120, Willow Slough Channel Relocation and Levee Construction, February 1947, Drawing No. 50-4-2281 Sheet 4 (Station 271+54)] FS Date: 5/5/2015 8:02:11 AM

Landside view- beyond grass area see drainage inlet

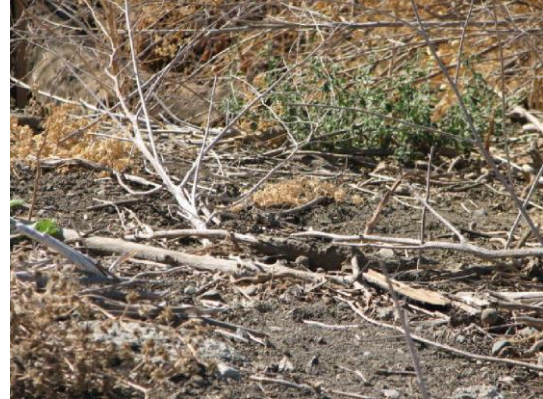
Photo 2 of 3 : UCIP_FA_2019_44903_22881.jpg

Waterside view- general view

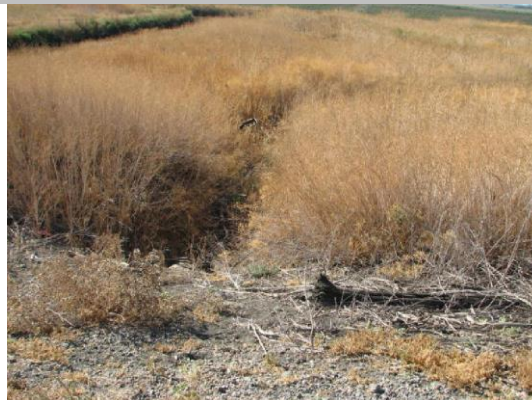
Photo 3 of 3 : UCIP_FA_2019_44903_22880.jpg

Waterside overview. Notice waterway.

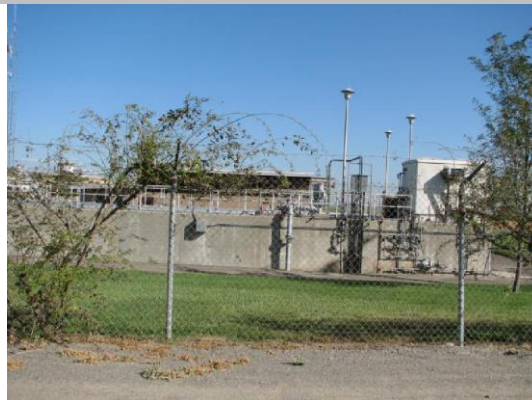
Photo 3 of 3 : UCIP_FA_2019_44904_22886.jpg

Landside overview- pumping plant not related with this crossing.

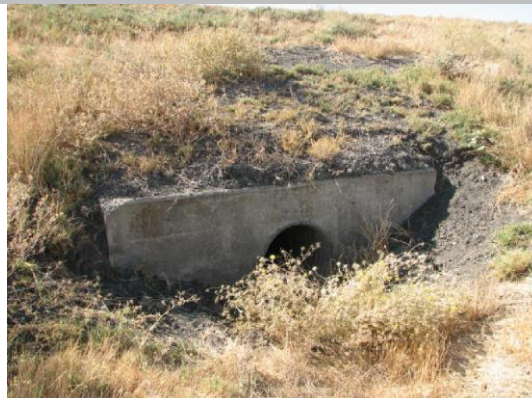
Photo 1 of 3 : UCIP_FA_2019_44907_22894.jpg

Comment Code					
Inspector Comment					
DS_ID:17608 FS_ID:44907 EP_NO: 10313 Repair Type: No Action Needed Crossing Status: Found UCIP Comments: 04/12/2017 LS - dump has it plugged, WS - ditch need to be established debris higher than water, inspected by JK, RF. (DWR Sacramento Yard - C. Lund) 09/19/2012 Pipe sits on concrete saddle on WS. (DWR UCIP - P. Amatya) FIELD_STRUCT_DESC: 24-inch corrugated metal drainage pipe through the levee, 13.5 feet below the crown. Flap gate is located on the waterside (WS) end. (24-inch pipe [HLM 0.79] authorized under Automatic Board Order (ABO) issued as Permit No. 10313, 1974 - Lear). [Additional Reference(s): DWR Levee Log, 1990. USACE Sacramento O&M Manual Unit 120, Willow Slough Channel Relocation and Levee Construction, February 1947, Drawing No. 50-4-2281 Sheet 2, 4 (Station 232+43)] FS Date: 5/5/2015 8:06:14 AM

Landside view- pipe and headwall

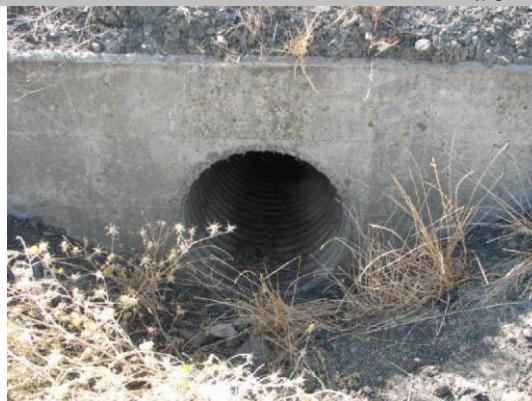
Photo 2 of 3 : UCIP_FA_2019_44907_22893.jpg

Landside view- pipe and headwall closer view

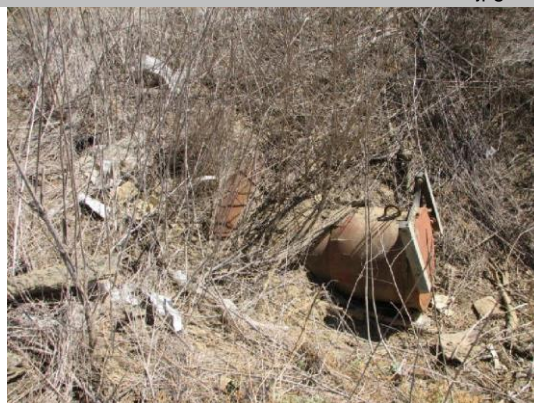
Photo 1 of 3 : UCIP_FA_2019_44929_22929.jpg

Comment Code						
Inspector Comment						
DS_ID:17623						
FS_ID:44929						
EP_NO: 10310						
Repair Type: No Action Needed						
Crossing Status: Found						
UCIP Comments:						
FIELD_STRUCT_DESC: 20-inch steel drainage pipe sleeved though 30-inch corrugated metal pipe through the levee, 12.5 feet below the crown. 24-inch flap gate is located on the waterside (WS) end. (30-inch pipe [HLM 1.53] authorized under Automatic Board Order (ABO) issued as Permit No. 10310, 1974 - Hunt-Wesson Foods, Inc.) [Additional Reference(s): DWR Levee Log, 1990. USACE Sacramento O&M Manual Unit 120, Willow Slough Channel Relocation and Levee Construction, February 1947, Drawing No. 50-4-2281 Sheet 2 (Station 192+88)]						
FS Date: 5/5/2015 8:20:02 AM

Waterside view- pipe and flap gate

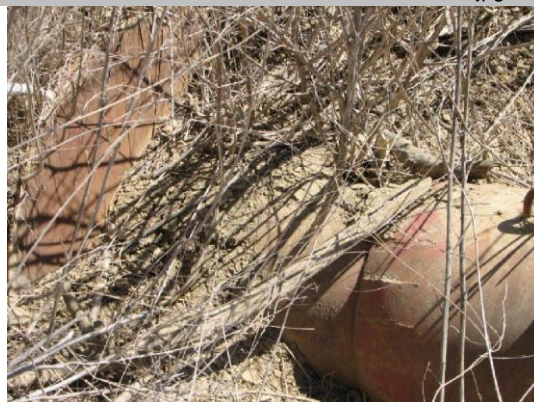
Photo 2 of 3 : UCIP_FA_2019_44929_22928.jpg

Waterside view- 20-inch pipe sleeved into 30-inch pipe

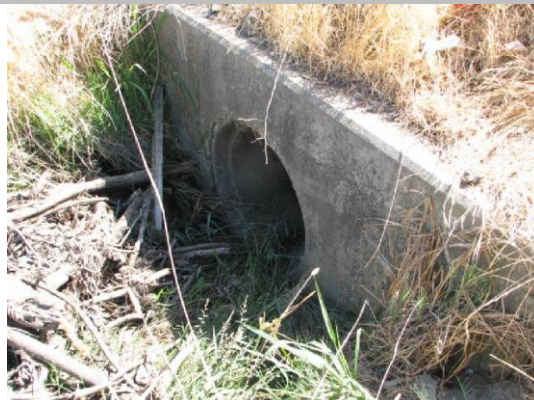
Photo 1 of 3 : UCIP_FA_2019_44937_22951.jpg

Item	DRAFT DWR UCIP LMA Responsibility		38.590390°	38.590390°								
			-121.702470°	-121.702470°								
DWR ID	17619											
Comment Code												
Inspector Comment												
DS_ID:17619 FS_ID:44937 EP_NO: 10307 Repair Type: No Action Needed Crossing Status: Found UCIP Comments: 04/26/2017 LS - removed debris and needs to be sprayed, work completed by JK, MH. (DWR Sacramento Yard - C. Lund) 04/12/2017 LS - good/clear, WS - little debris (handwork-cleared) , inspected by JK, RF. (DWR Sacramento Yard - C. Lund) 05/28/2013 flap gate cleaned and standpipe repaired. (DWR Sacramento Yard - C. Lund) 09/19/2012 The 48-inch concrete manhole damaged - top ring knocked off in waterside. Debris found in waterside pipe. (DWR UCIP - P. Amatya) FIELD_STRUCT_DESC: 24-inch drainage pipe of unknown material through the levee, 10 feet below the crown. Flap gate is located on the waterside (WS) end. Concrete headwall is located on the WS and landside (LS) ends. Slide gate is located inside a 48-inch manhole located on the WS slope. (24-inch pipe [HLM 2.04] authorized under Automatic Board Order (ABO) issued as Permit No. 10307, 1974 - Beckman). [Additional Reference(s): DWR Levee Log, 1990. USACE Sacramento O&M Manual Unit 120, Willow Slough Channel Relocation and Levee Construction, February 1947, Drawing No. 50-4-2281 Sheet 2 (Station 165+69)] FS Date: 5/5/2015 8:25:25 AM

Landside view- concrete pipe and headwall.

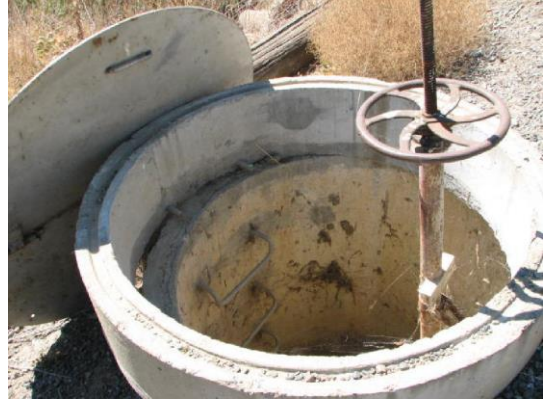
Photo 3 of 3 : UCIP_FA_2019_44937_22948.jpg

Waterside view- concrete manhole.

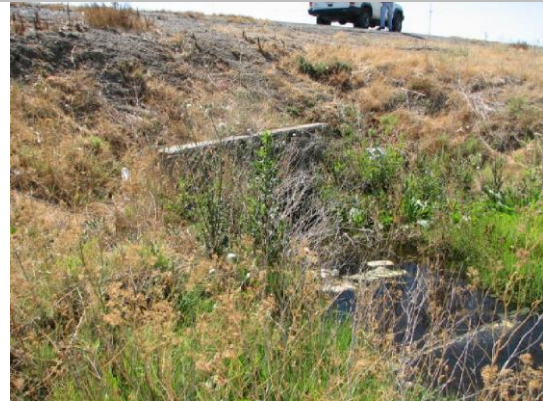
Photo 1 of 3 : UCIP_FA_2019_55422_22962.jpg

Comment Code						
Inspector Comment						
DS_ID:17620 FS_ID:55422 EP_NO: 10311 Repair Type: Non-Urgent Crossing Status: Found UCIP Comments: 11/01/2019 Received information from Vincent Rodriguez - FMO that this pipe was lined using the CIPP method on April 18, 2019. Removed Urgent status and will follow up with inspection photo. (O.Yakimov - DWR UCIP)04/09/2019 Grouted 10-foot into the pipe on the WS. Internal inspection has been completed and it shows major erosion of pipe. Recommend complete removal and replacement. Pipe is in a section of major county road (Road 29). (J. McCabe - DWR Sacramento Yard)04/12/2017 good/clear on LS & WS, inspected by JK, RF. (DWR Sacramento Yard - C. Lund) 05/28/2013 Some small vegetation removal is needed on landside of the levee. (DWR Sacramento - C. Lund) 09/19/2012 Vegetation removal on landside of the levee. (DWR UCIP - P. Amatya) FIELD_STRUCT_DESC: 24-inch corrugated metal drainage pipe through the levee, 10 feet below the crown. Flap gate is located on the waterside (WS) end. (24-inch pipe [HLM 2.95] authorized under Automatic Board Order (ABO) issued as Permit No. 10311 - Ittner and Harlan). [Additional Reference(s): DWR Levee Log, 1990. USACE Sacramento O&M Manual Unit 120, Willow Slough Channel Relocation and Levee Construction, February 1947, Drawing No. 50-4-2281 Sheet 1 (Station 118+00)] FS Date: 11/1/2019 8:16:07 AM

Landside view- inlet structure

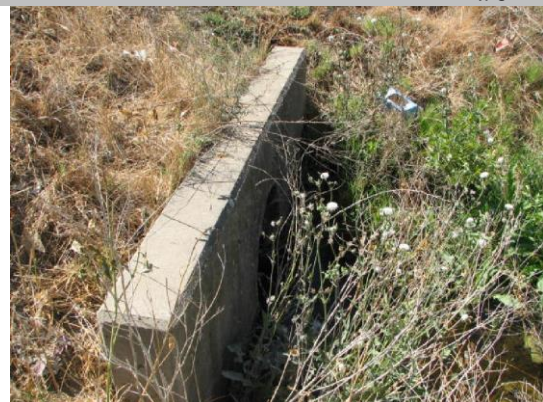
Photo 2 of 3 : UCIP_FA_2019_55422_22961.jpg

Landside view- concrete headwall

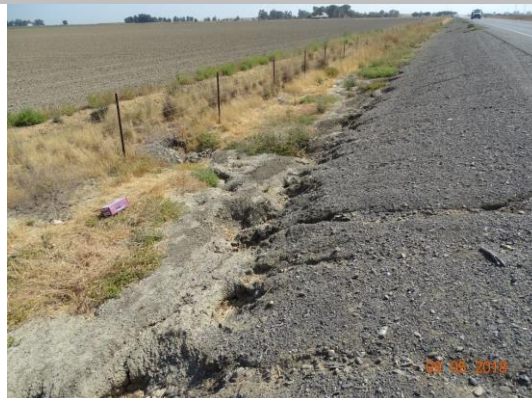
Photo 1 of 3 : FA_2019_ST0012_295_10_20190829_00002.jpg

View of the erosion on the landside slope. Fall 2018.

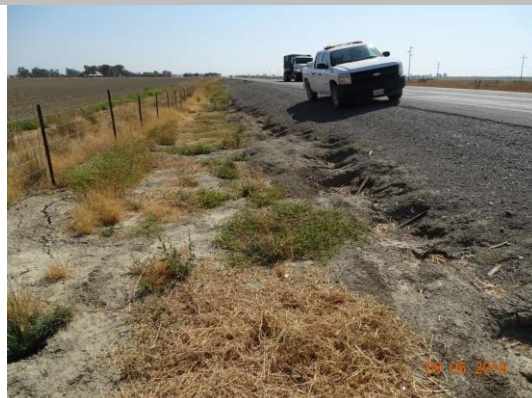
Photo 2 of 3 : FA_2019_ST0012_295_10_20190829_00003.jpg

Additional view of the erosion on the landside slope. Fall 2018.

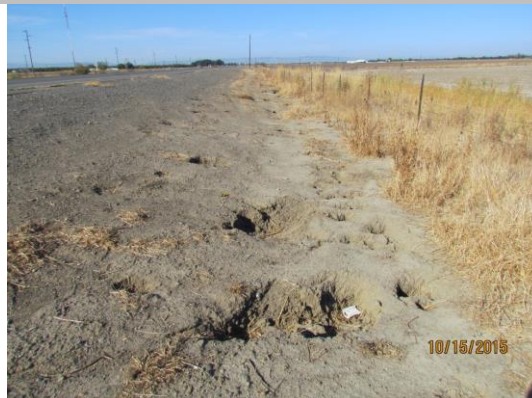
Photo 3 of 3 : FA_2019_ST0012_295_10_20190829_00004.jpg

View of the erosion on the landward side of the levee looking upstream.
Fall 2015.

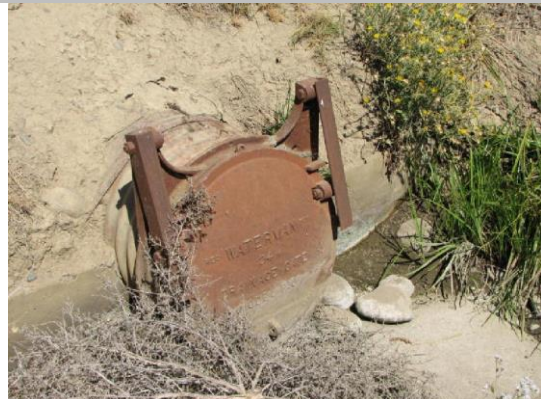
Photo 2 of 3 : UCIP_FA_2019_55421_22970.jpg

Waterside view- pipe and flap gate (close view).

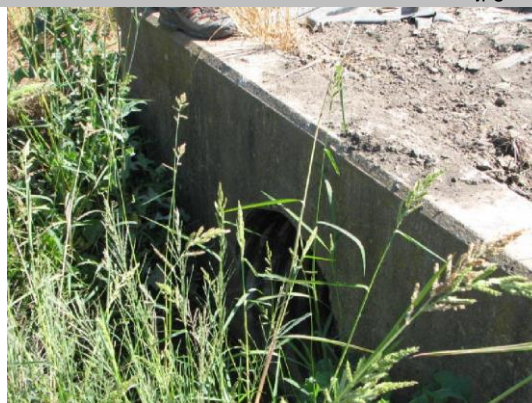
Photo 3 of 3 : UCIP_FA_2019_55421_22969.jpg

Landside view- pipe and concrete headwall.

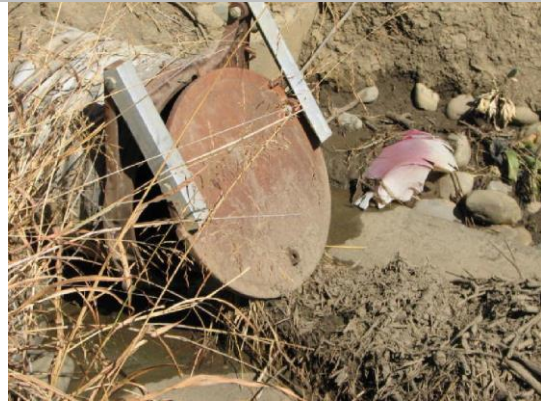
Photo 3 of 3 : UCIP_FA_2019_44947_22986.jpg

Waterside view- pipe, flap gate and debris. The pipe sits on concrete saddle.

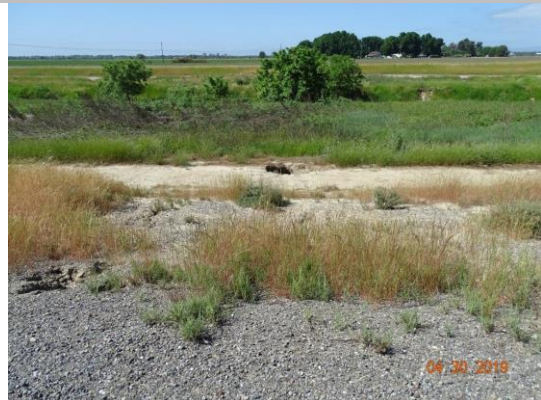
Photo 1 of 1 : FA_2019_ST0012_295_23_20190829_00007.jpg

LM Start	3.69	Rating **	M	Issue No.	23
LM End	3.69	Issue Type +	Ma	Location *	WS
Category	Earthen Levee			GPS Latitude/Longitude	
				Start	End
Item	Erosion / Bank Caving			38.591699 °	38.591699 °
				-121.733066 °	-121.733066 °
DWR ID	DWR_ST0012_01_s_2019_23				
Comment Code					
E2 : Schedule repair of erosion site prior to the next inspection.					
Inspector Comment					
Appears to be runoff erosion on the waterside slope and toe road.

View of hole on the toe road. Spring 2019.

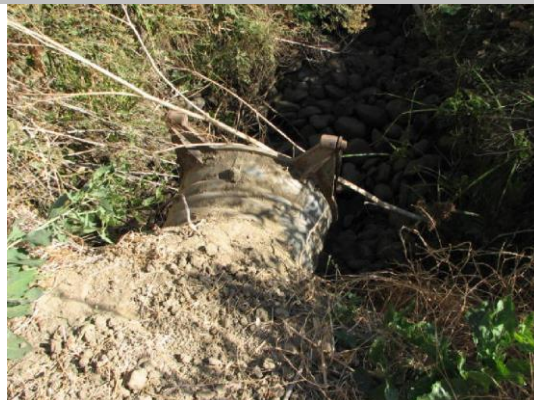
Photo 3 of 3 : UCIP_FA_2019_45286_22461.jpg

Waterside view- CM pipe and flap gate.

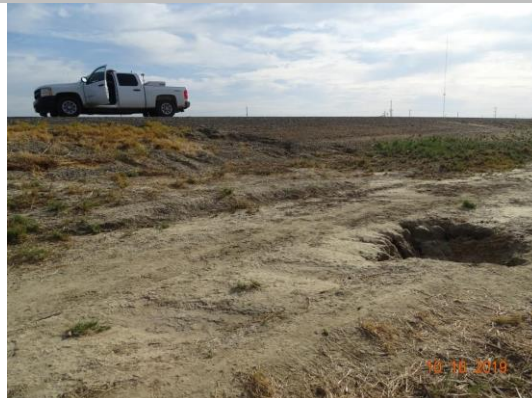
Photo 1 of 1 : FA_2019_ST0012_296_24_20191108_00049.jpg

View of erosion on waterside slope and toe road. Fall 2019.

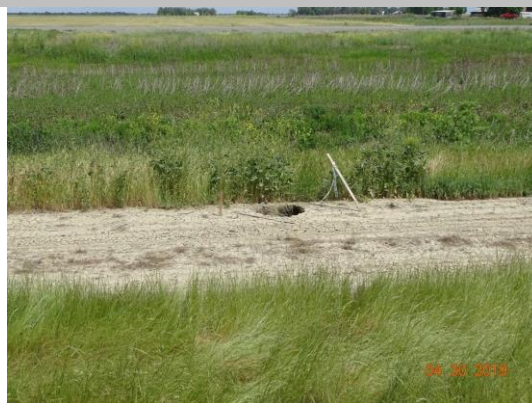
Photo 1 of 1 : FA_2019_ST0012_296_28_20190829_00006.jpg

View of erosion on the waterside toe road. Spring 2019.

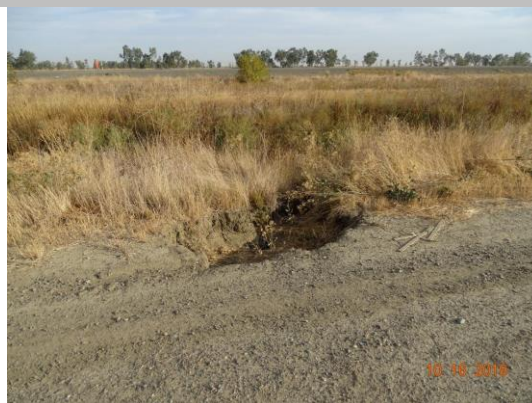
Photo 1 of 1 : FA_2019_ST0012_296_19_20191108_00048.jpg

View of erosion on toe road. Fall 2019.

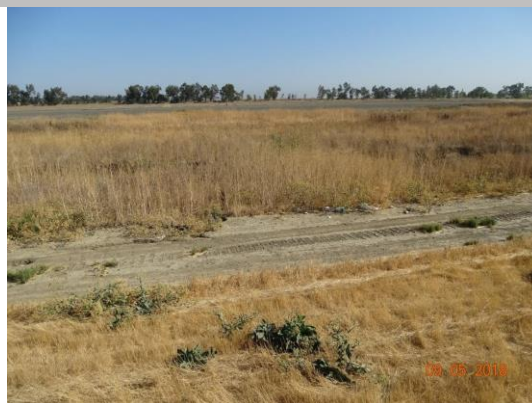
Photo 1 of 2 : FA_2019_ST0012_296_10_20190829_00004.jpg

View of erosion on the waterside toe road. Fall 2018.

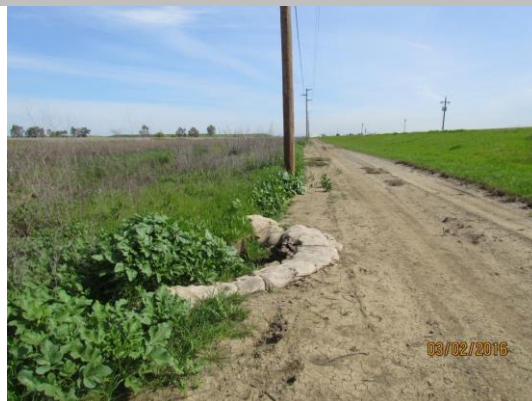
Photo 2 of 2 : FA_2019_ST0012_296_10_20190829_00005.jpg

View of the erosion on the toe road looking downstream. Spring 2016.

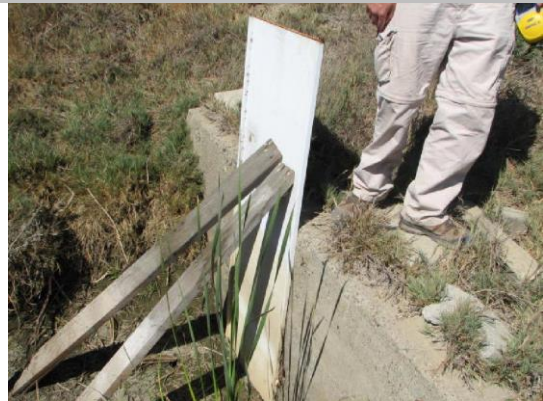
Photo 1 of 3 : UCIP_FA_2019_45291_22479.jpg

Landside view- concrete headwall and pipe (temporarily closed used wooden planks).

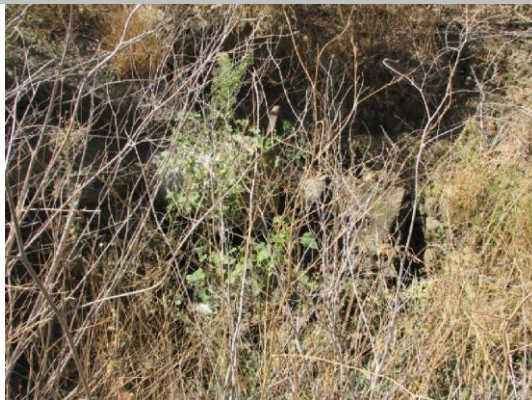
Photo 1 of 3 : UCIP_FA_2019_45298_22805.jpg

Waterside overview- pipe and flap gate with dense vegetation.

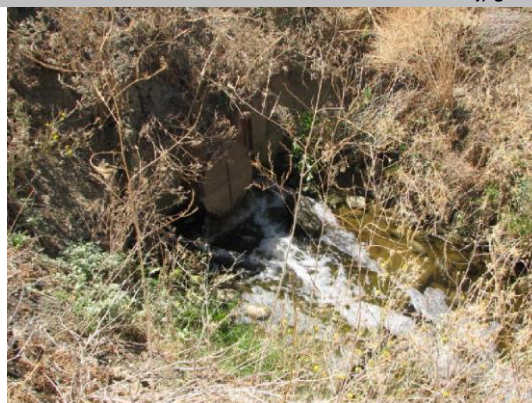
Photo 3 of 3 : UCIP_FA_2019_45301_22846.jpg

Waterside view- pipe and flap gate. Water was running in the pipe during the survey.

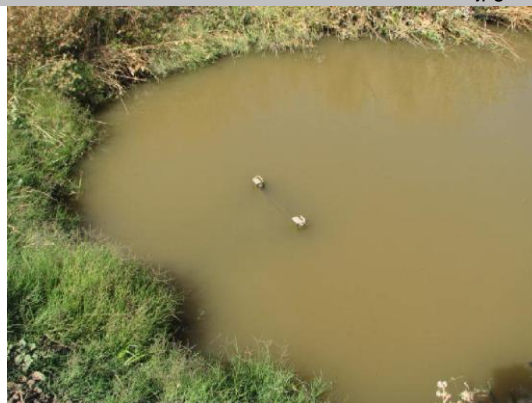
Photo 2 of 3 : UCIP_FA_2019_45307_22868.jpg

Waterside view- outlet structure under the water.
